Composite Failure Analysis Handbook Update #1

Boeing Defense & Space Group

April 1995

Final Report for the Period Aug 90 - Apr 95

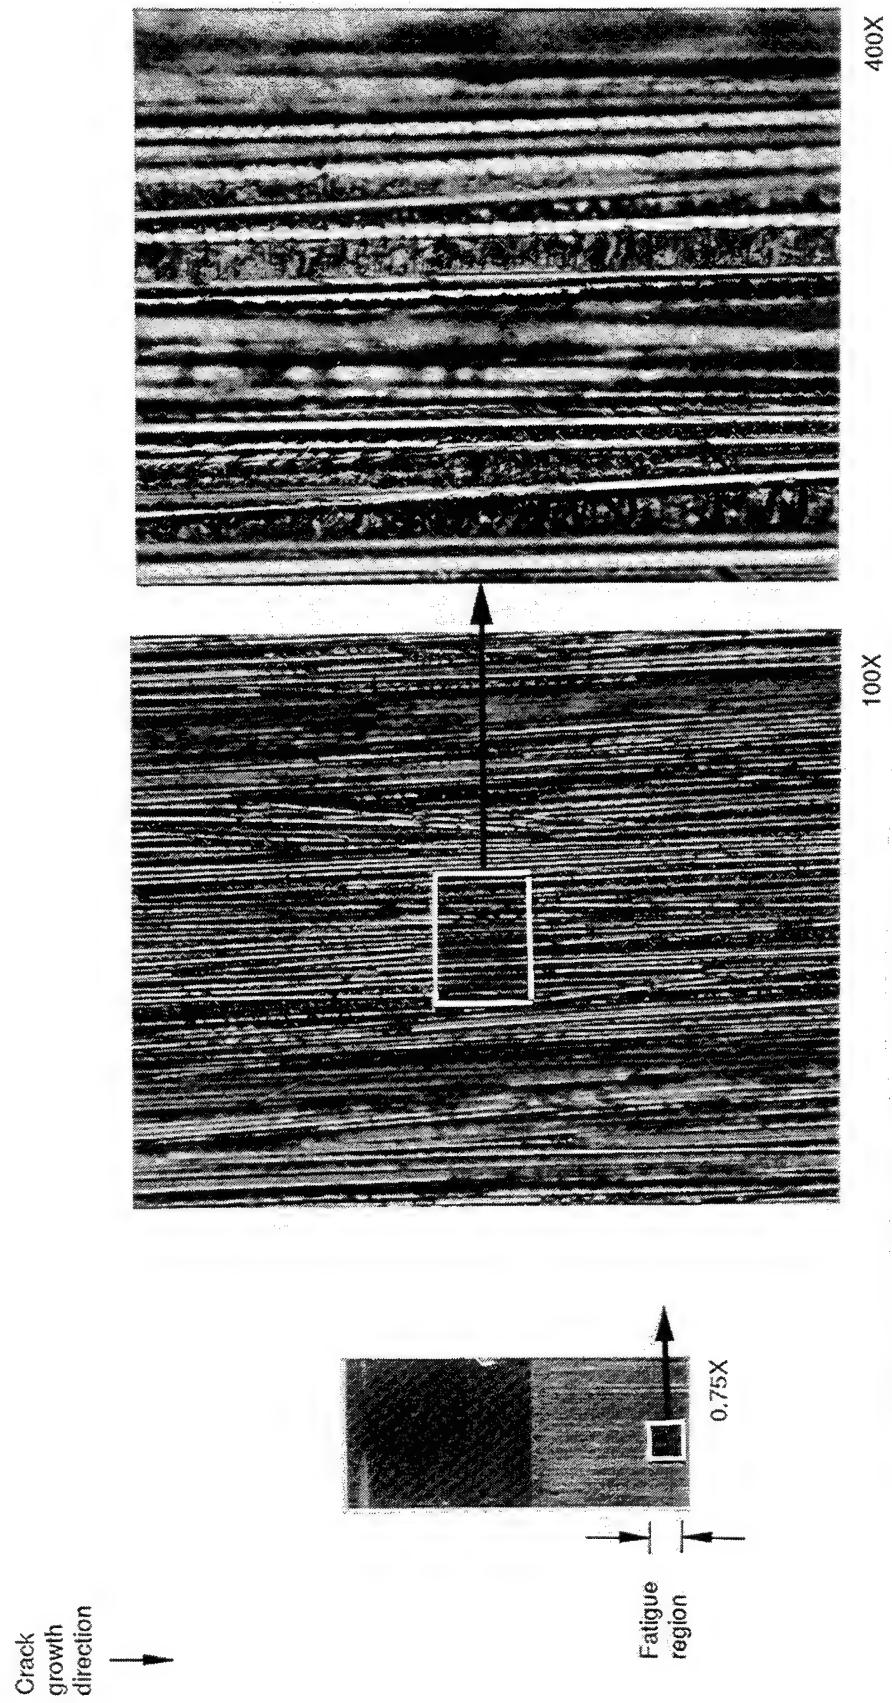
Figure 3.1-1. Optical Fractographs of 3501-6/AS4 Interlaminar Mode II (Shear) Fatigue, Low Stress Loading, 270°F

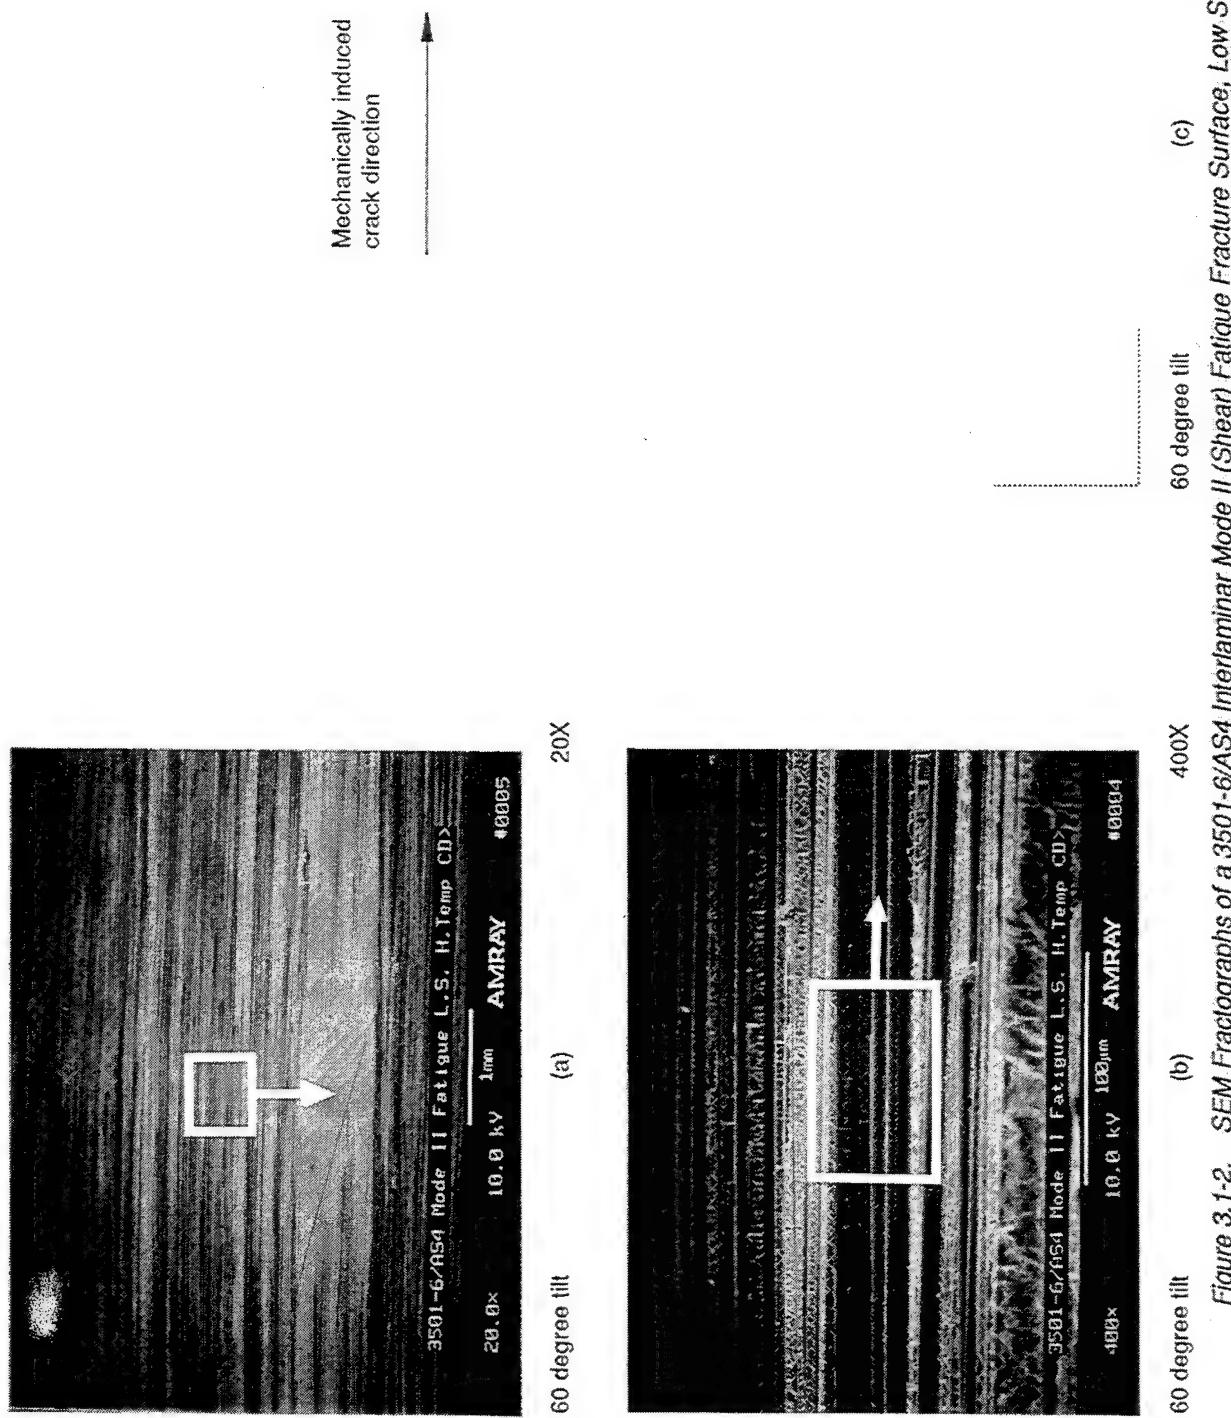
Figure 3.1-2. SEM Fractographs of a 3501-6/AS4 Interlaminar Mode II (Shear) Fatigue Fracture Surface, Low Stress, 270°F

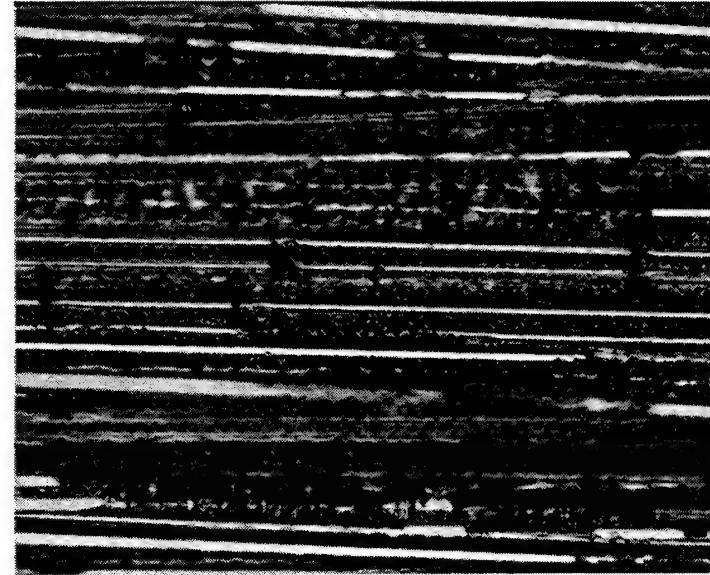
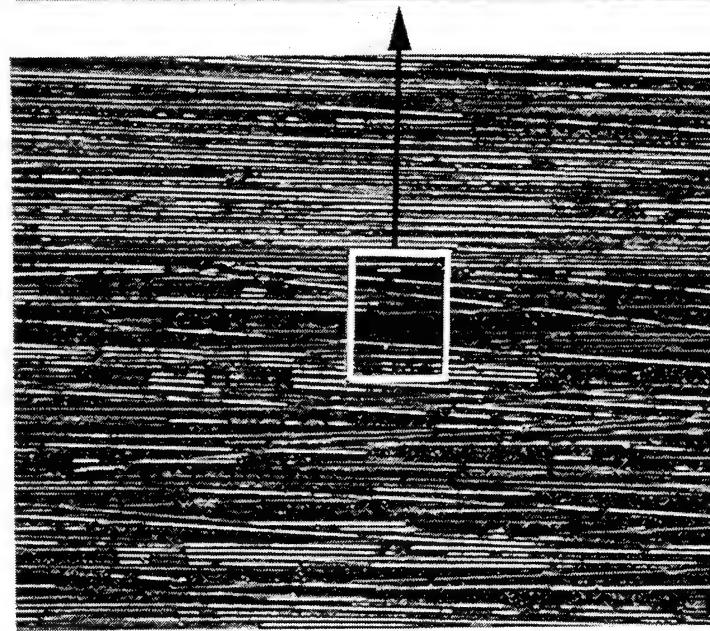
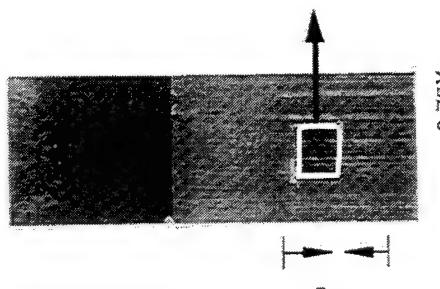
Figure 3.1-3. Optical Fractographs of 3501-6/AS4 Interlaminar Mode II (Shear) Fatigue, High Stress Loading, 270°F.

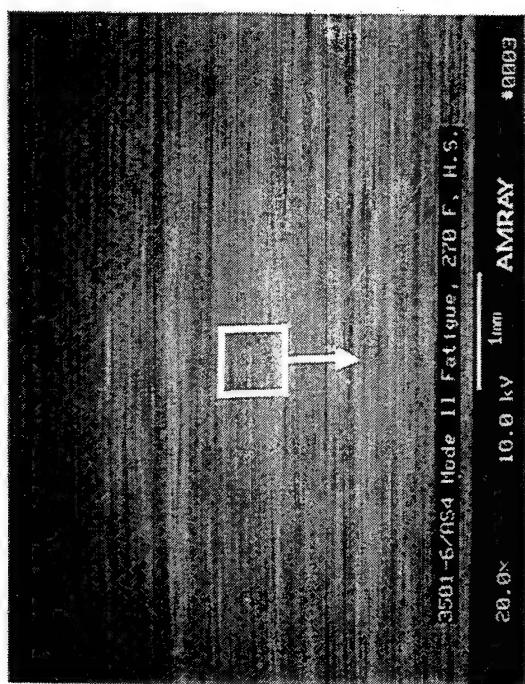
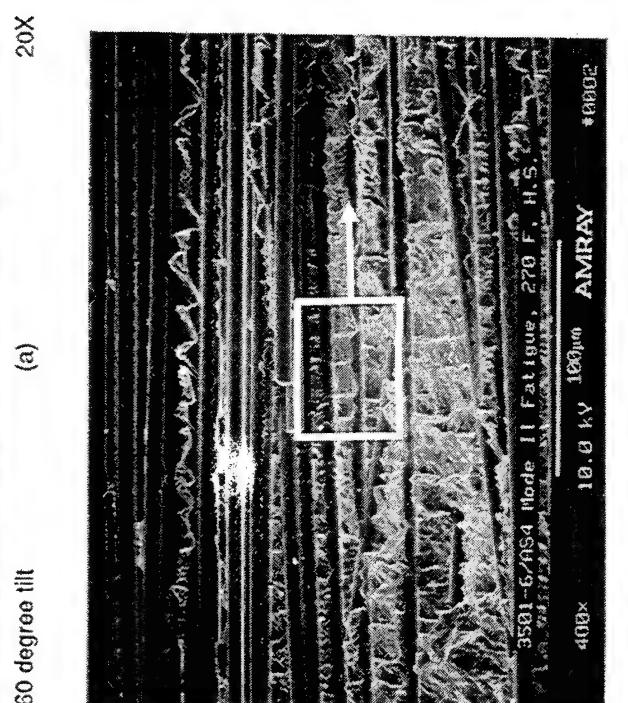
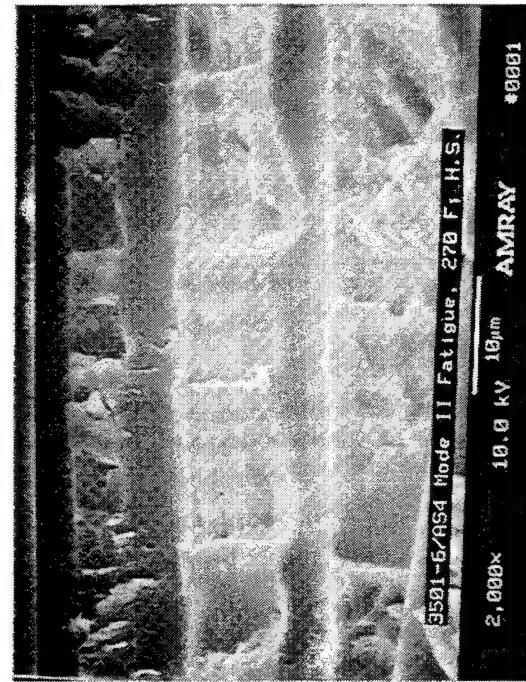
Figure 3.1-4. SEM Fractographs of a 3501-6/AS4 Interlaminar Mode II Fatigue Fracture Surface, High Stress, 270°F

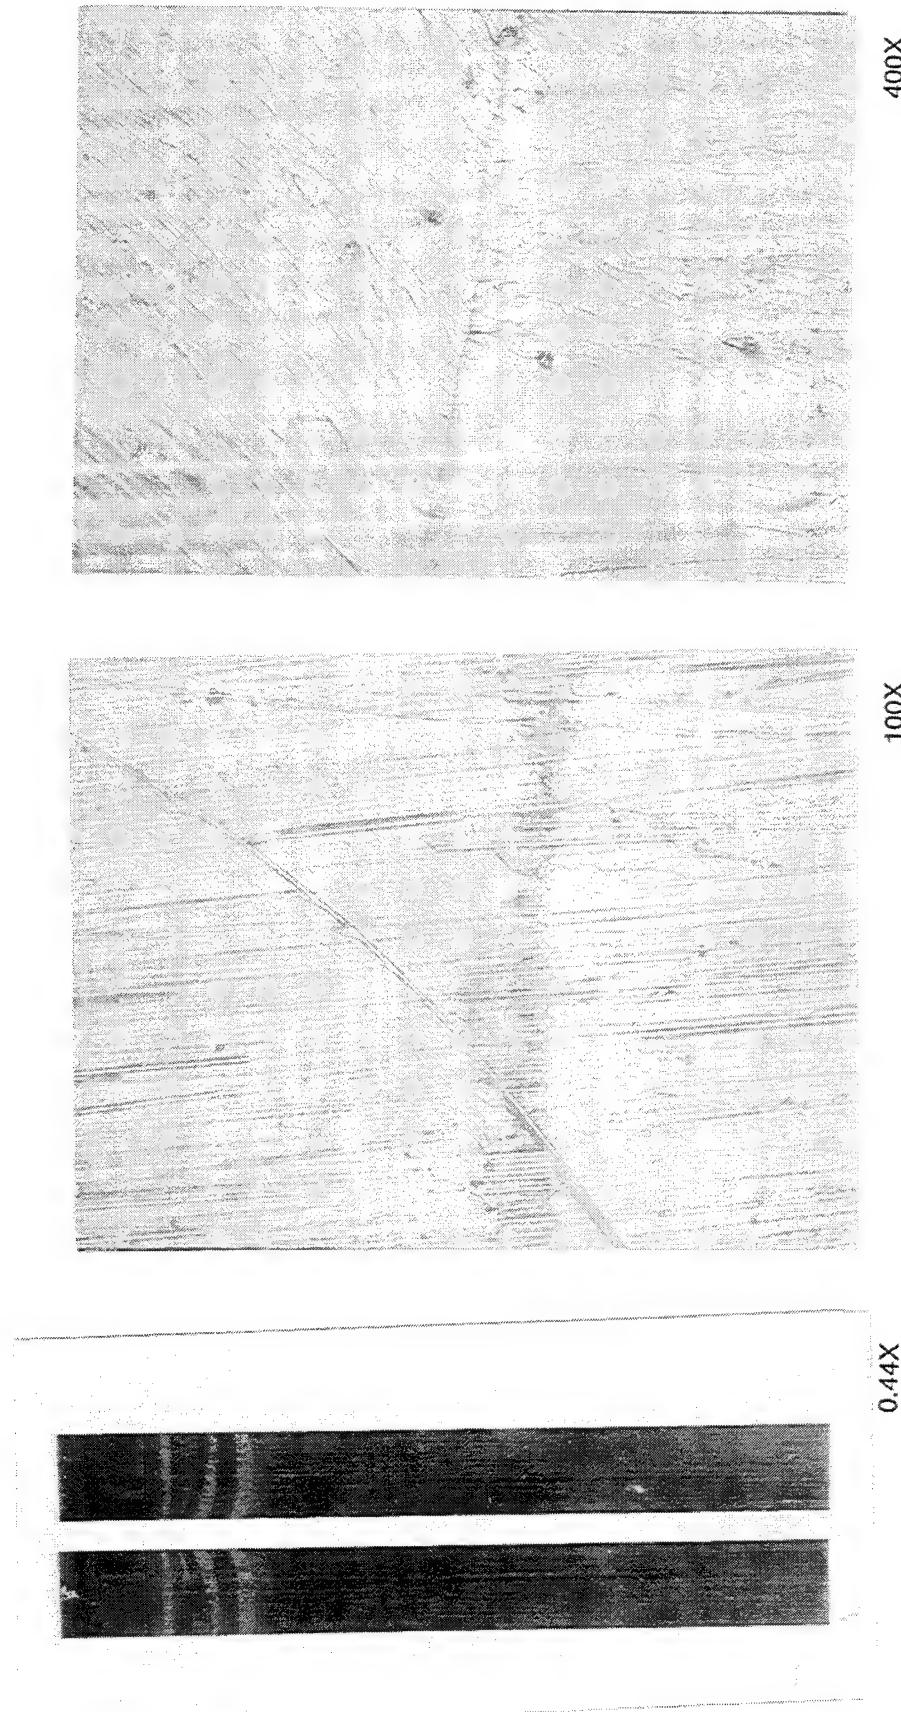
Figure 3.1-5. Optical Fractographs of a 3501/AS4 Interlaminar Mode I (Tensile) Fatigue Fracture Surface, 270° F

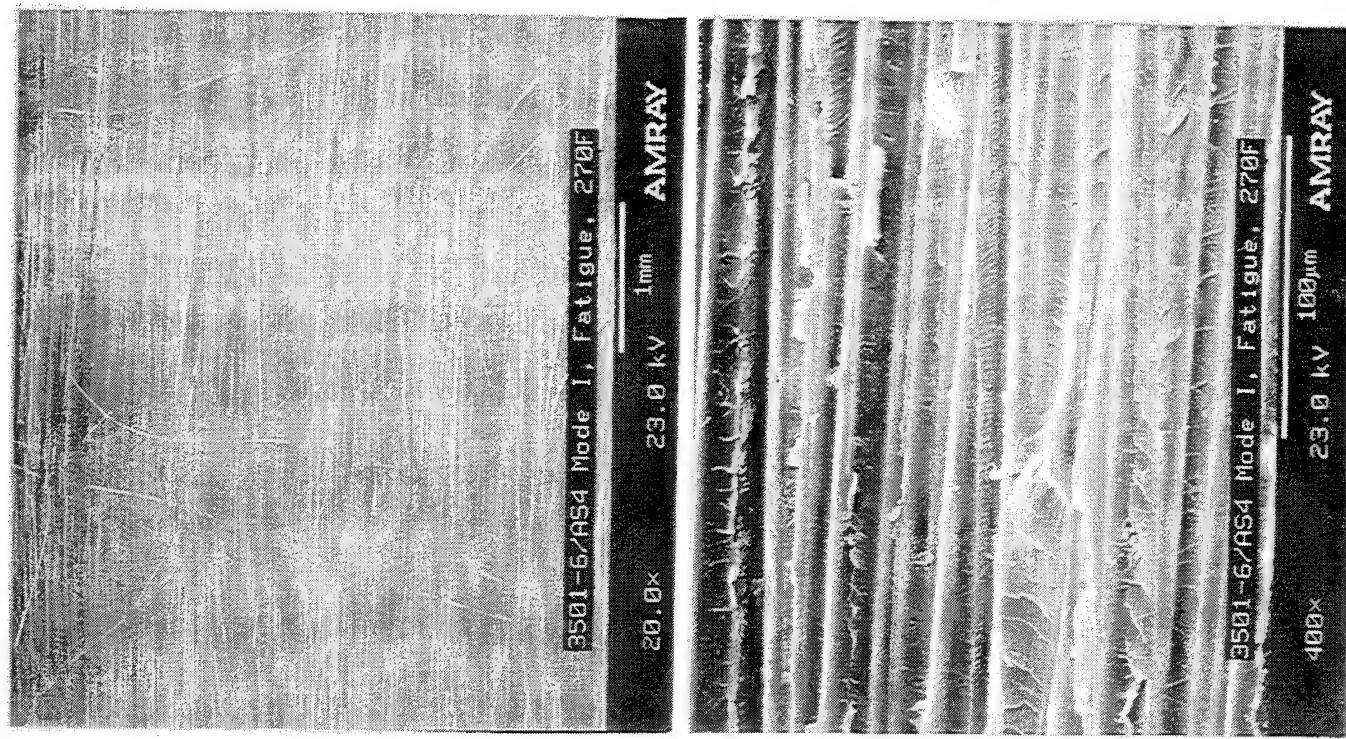
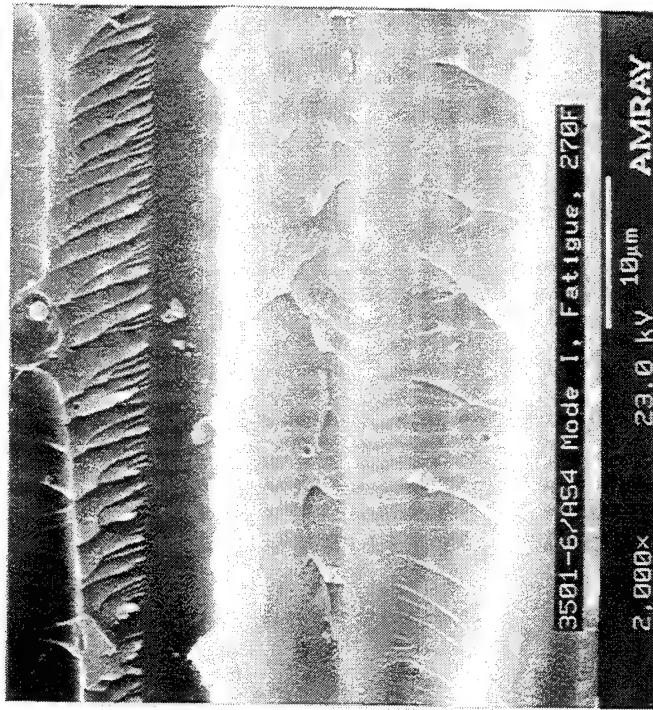
Figure 3.1-6. SEM Fractographs of a 3501/AS4 Interlaminar Mode I (Tensile) Fatigue Fracture Surface, 270° F

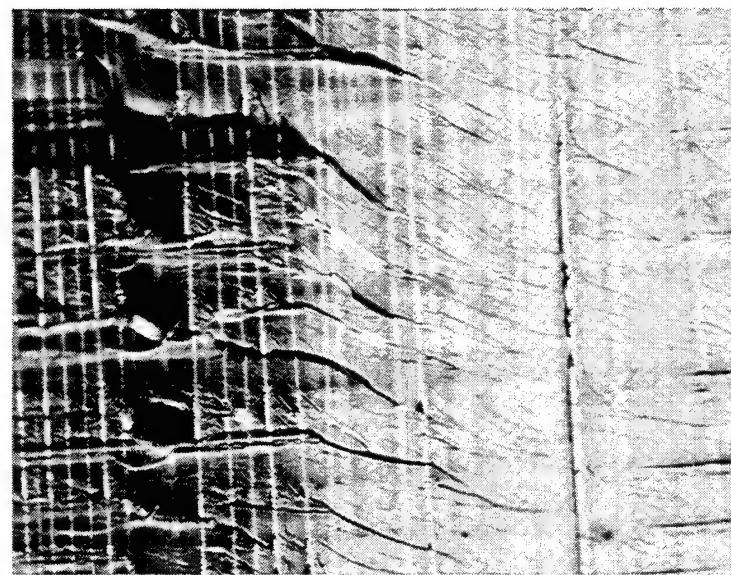
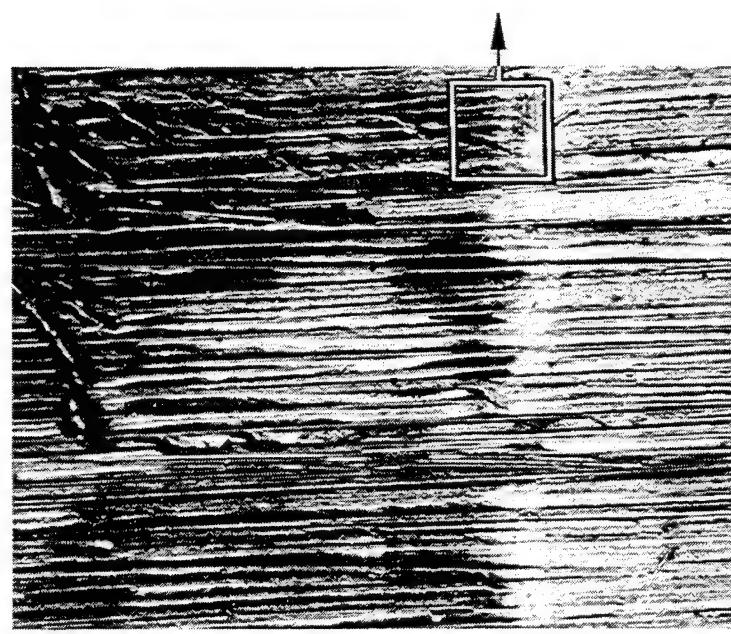
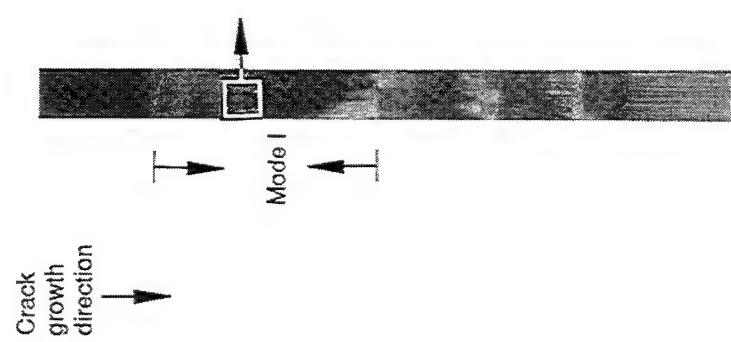
Figure 3.1-7. Optical Fractographs of 3501-6/AS4 Interlaminar Mode I Tension, Specimen Exposed to Deicing Fluid

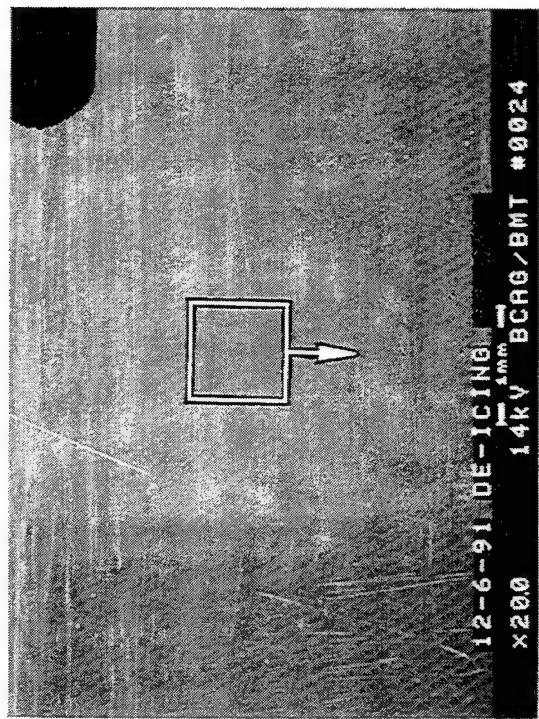
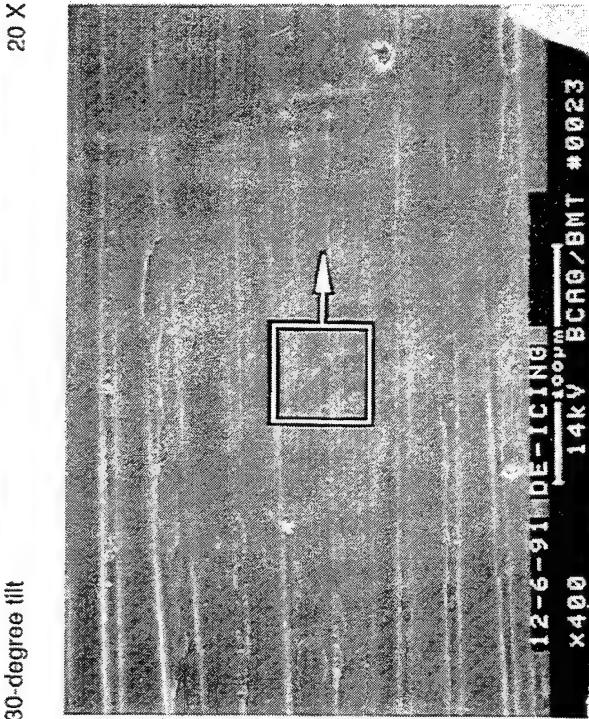
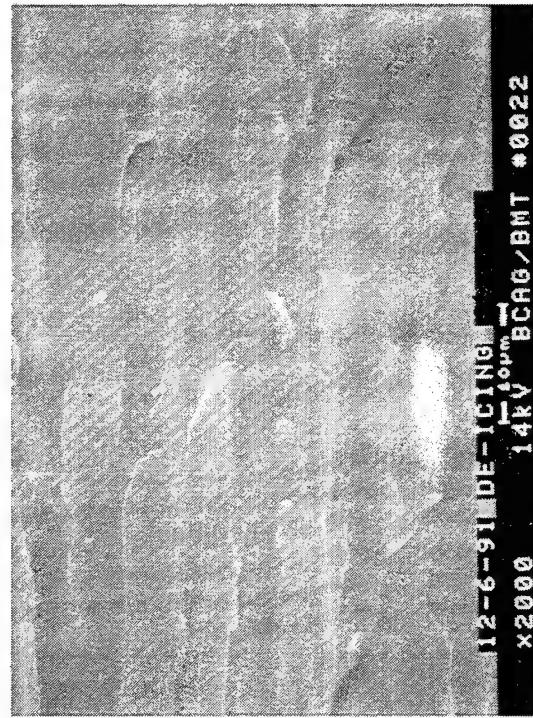
Figure 3.1-8. SEM Fractographs of 3501-6/AS4 Interlaminar Mode I Tension, Specimen Exposed to Deicing Fluid

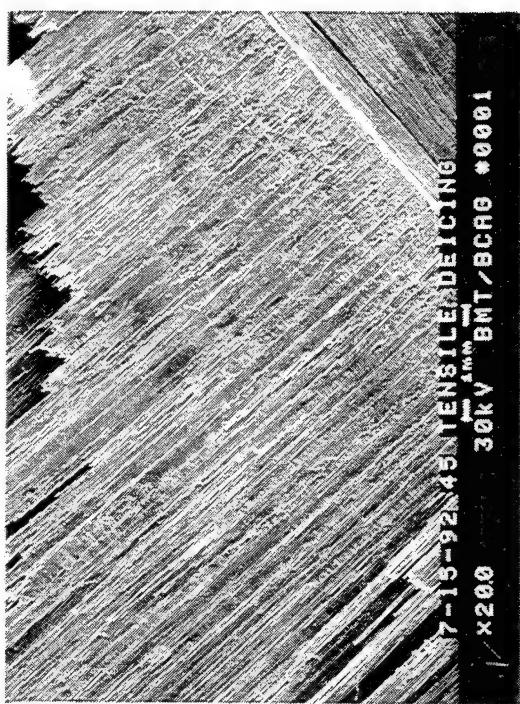
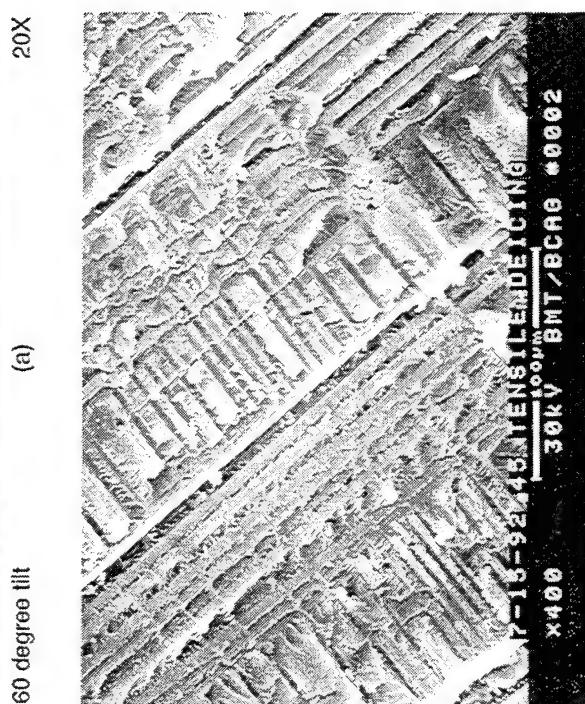
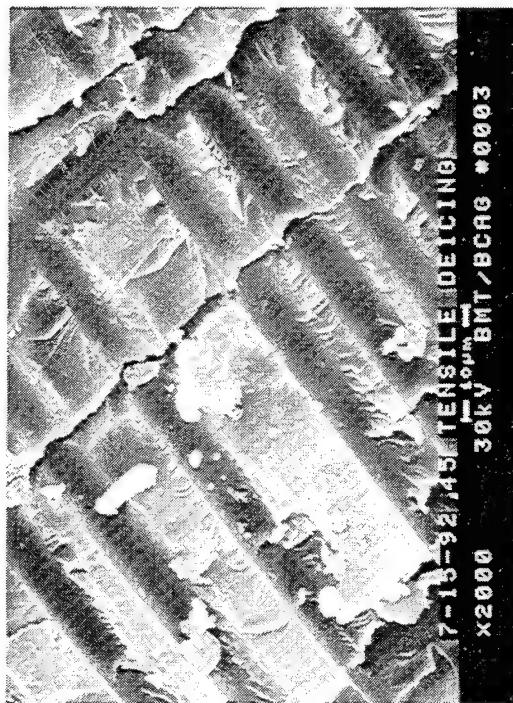
Figure 3-1-9. SEM Fractographs of a 3501-6/AS4 ± 45 Tensile Specimen Exposed to Deicing Fluid, Interlaminar Surface
49754.32 9-5571 D1 all

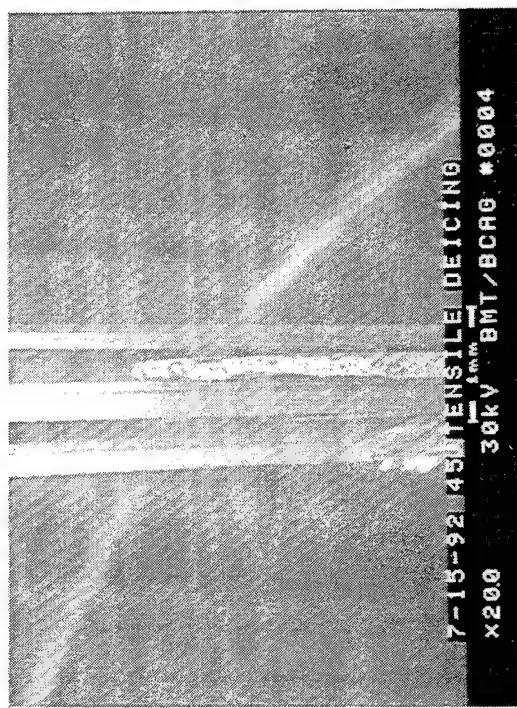
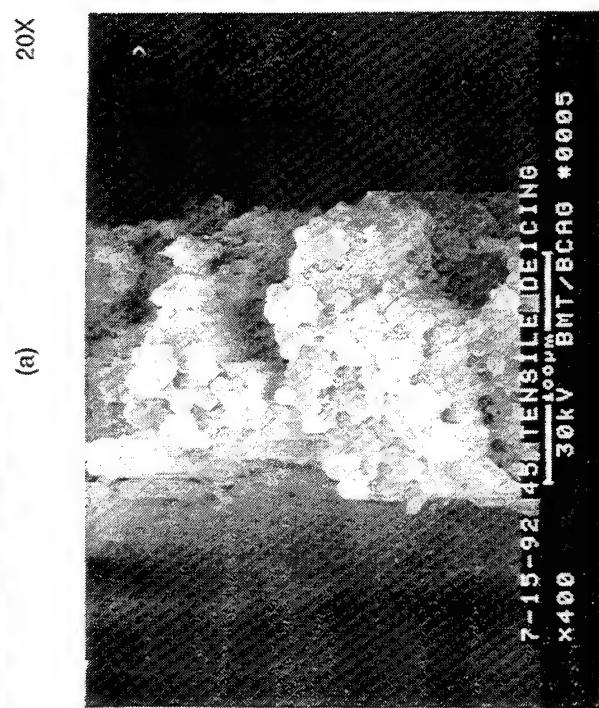
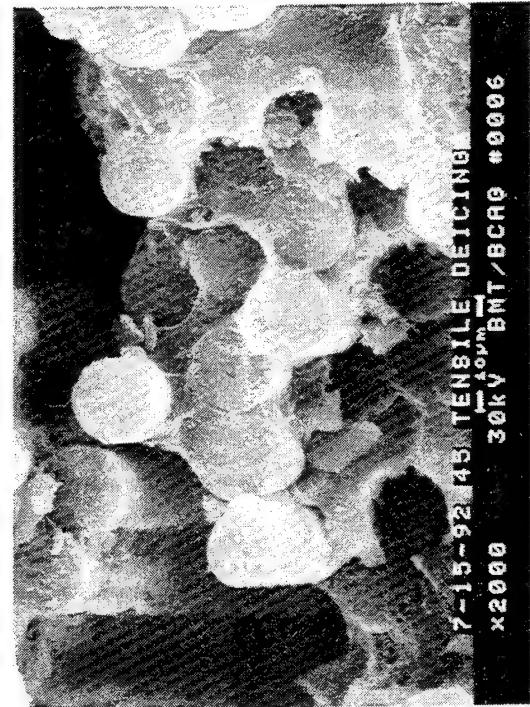
Figure 3.1-10. SEM Fractographs of a 3501-6/AS4 ± 45 Tensile Specimen Exposed to Deicing Fluid, Translaminar Surface

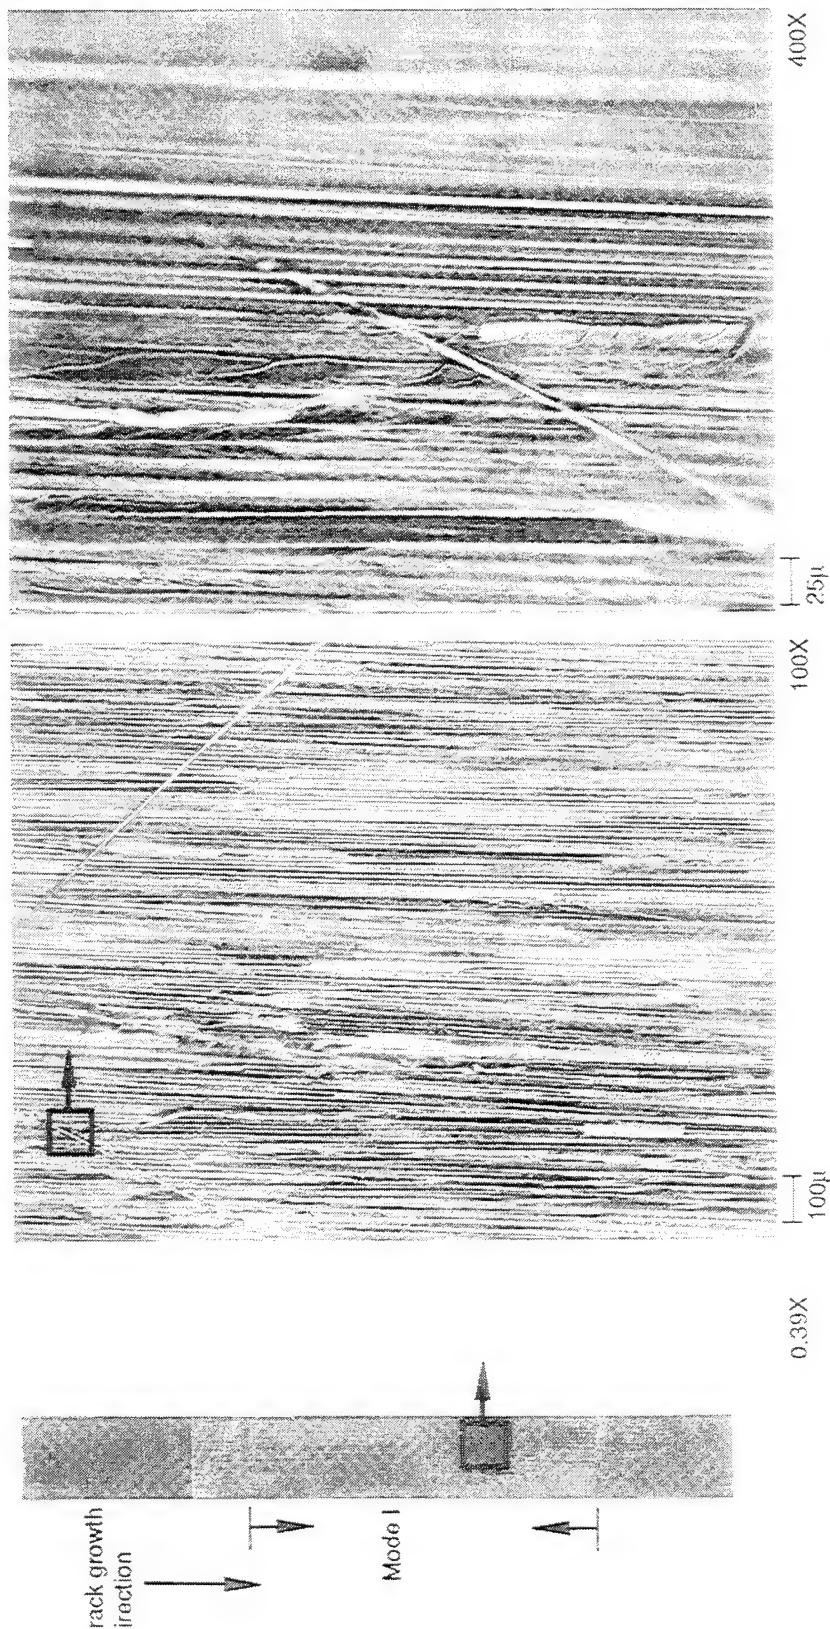
Figure 3.1-11. Optical fractographs of 3501-6AS4 interlaminar Mode I tension Specimen tested at -20°F (freezing Condition)

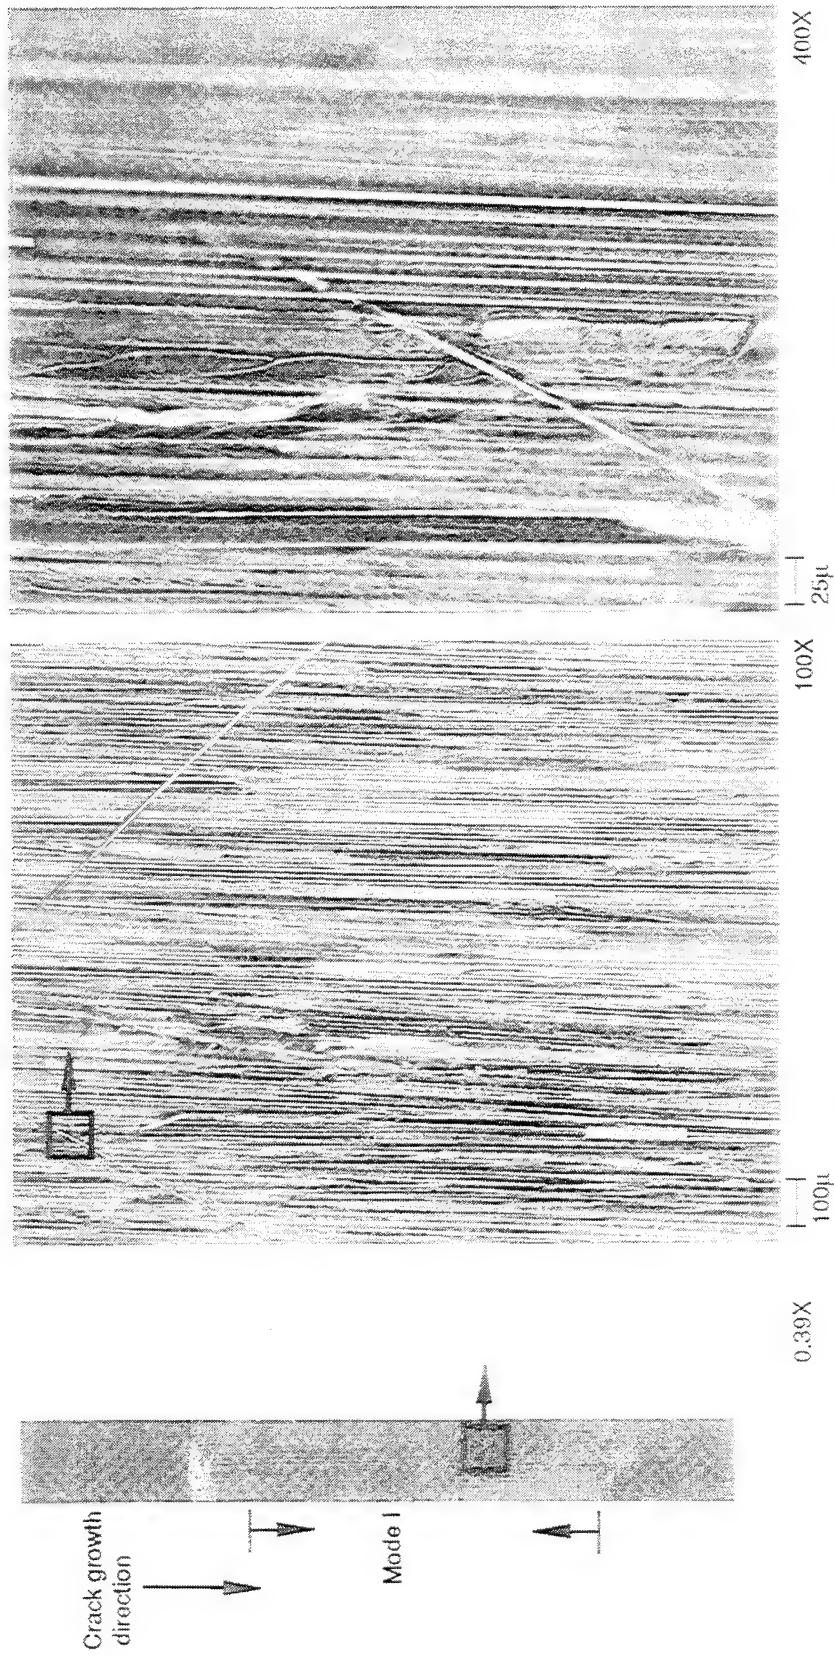
Figure 3.4-42. Optical fractographs of 3501-6/AS4 interlaminar Mode I tension Specimen Tested at -20°F (freezing Condition)

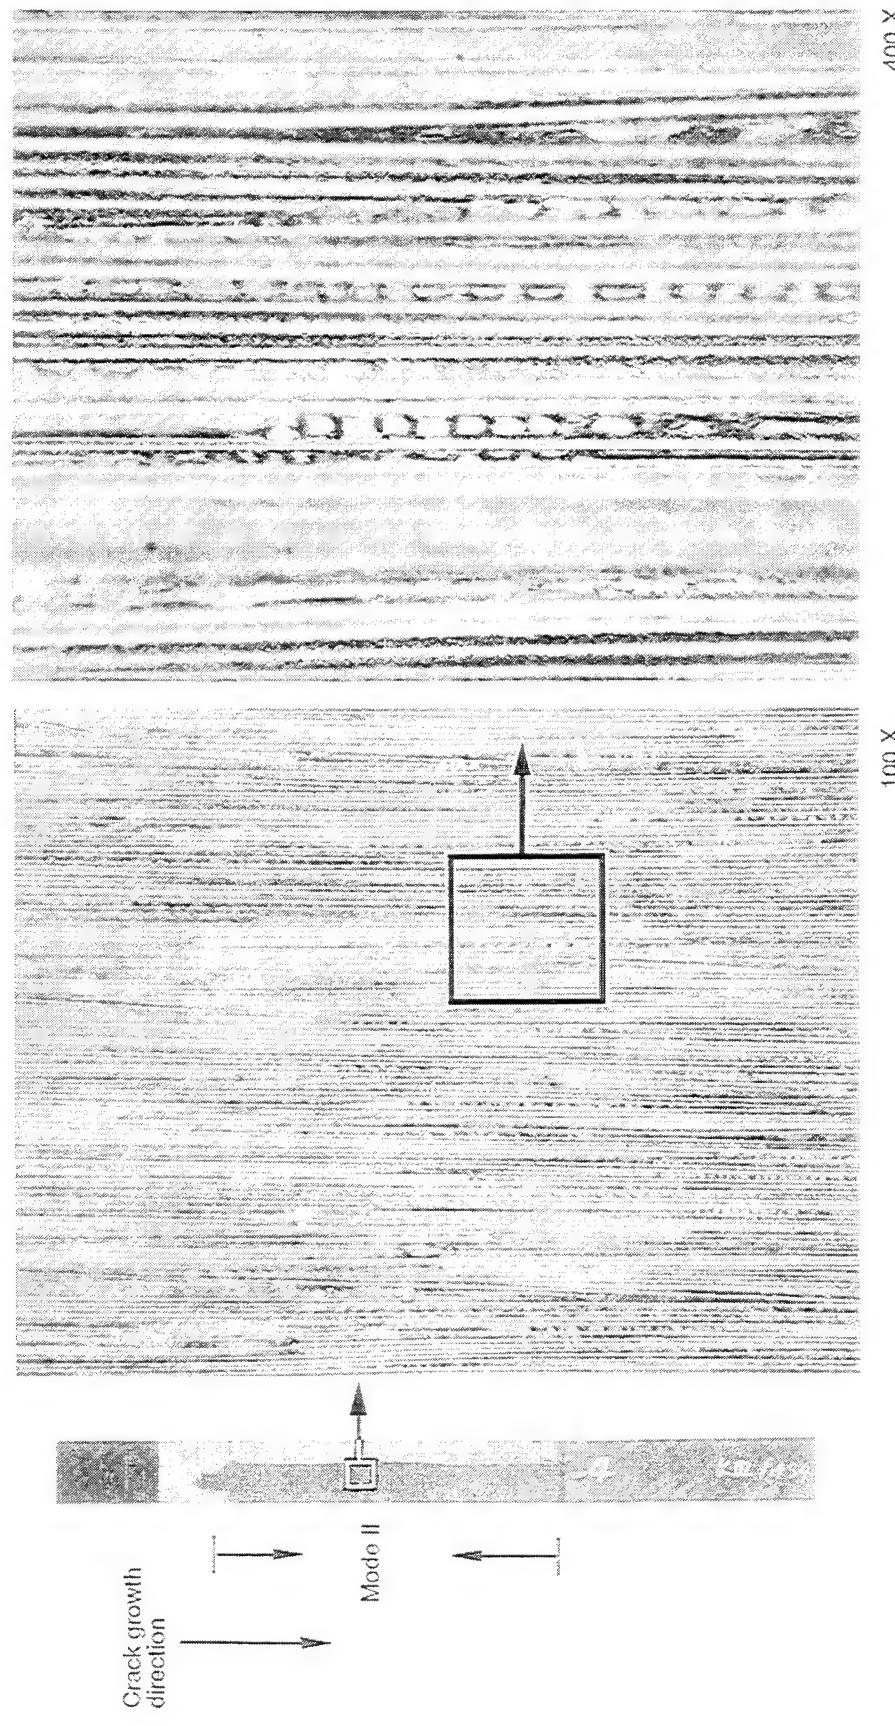
Figure 3.2.7. Optical fractography of KIII/AS4 interlaminar Mode II shear Specimen Tested at 400°F/Dy

There were no significant differences between the fracture morphology of the RT and the elevated temperature test specimens as shown in Figures 3.2-7 and 3.2-8.

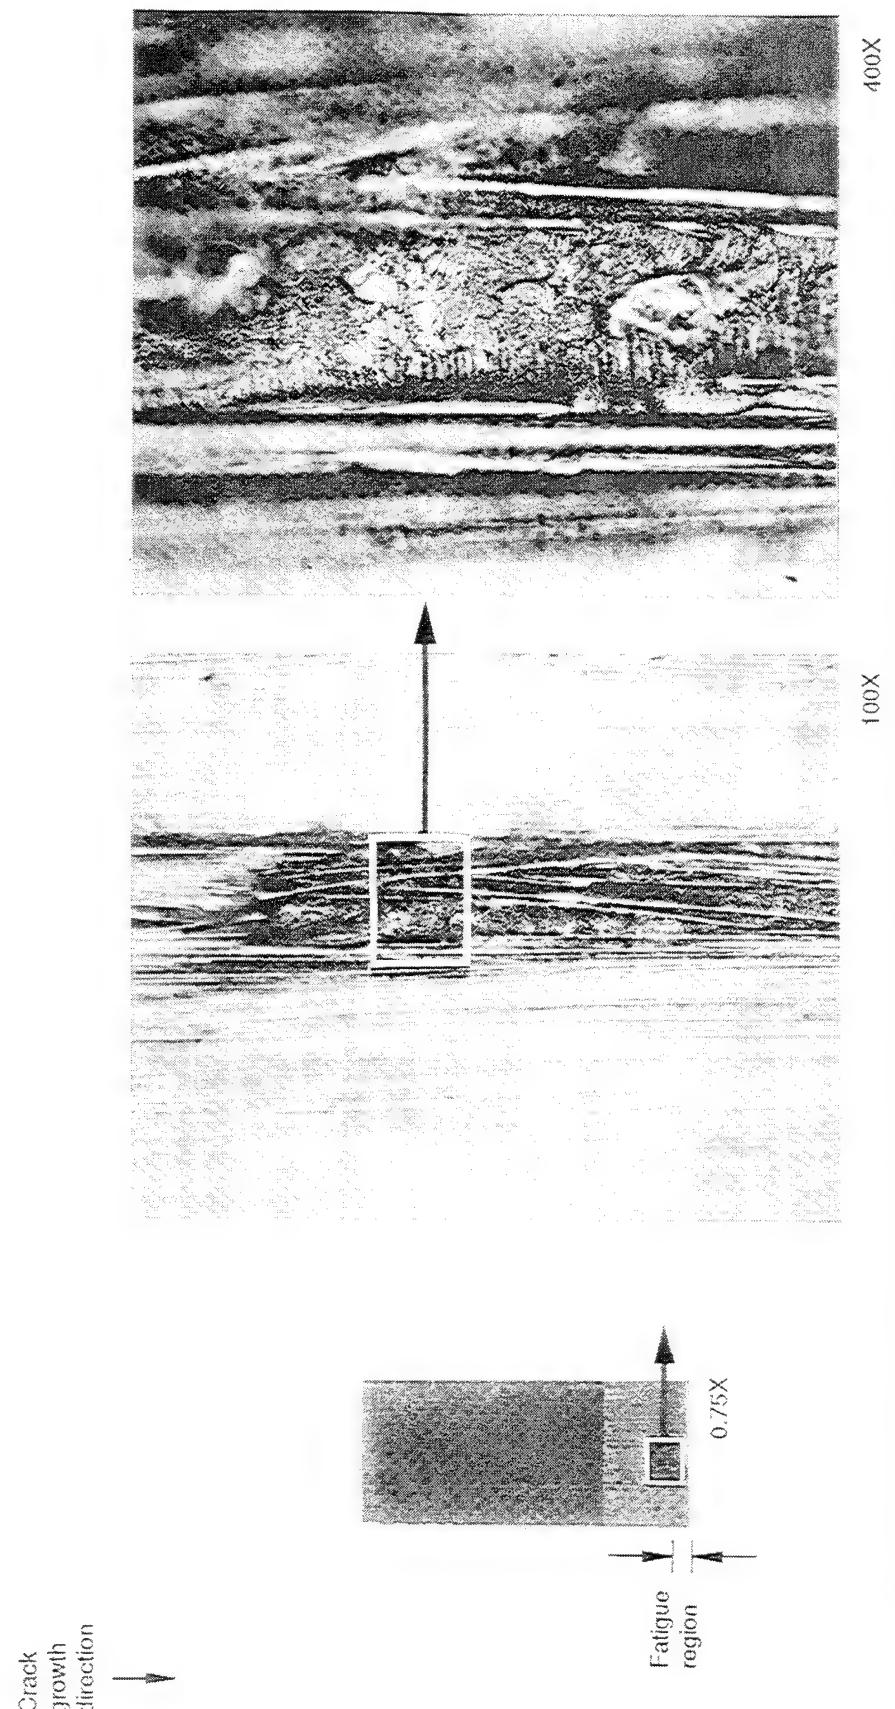
Figure 3.2-15. Optical Fractographs of K111/AS4 Interlaminar Mode II (Shear) Fatigue, Room Temperature, High Stress

Examination of the fracture surfaces did not reveal any definite indications of fatigue, except for a feature that may be related to the cyclic loading. This feature appeared to be typical of a mode II hackle. However, when observed at high magnification the feature appears to be wider and thinner than similar hackles on statically loaded specimens. This feature was observed both on the RT specimen (Figures 3.2-15 and 3.2-16) and the 350°F tested specimens (Figures 3.2-17 and 3.2-18).

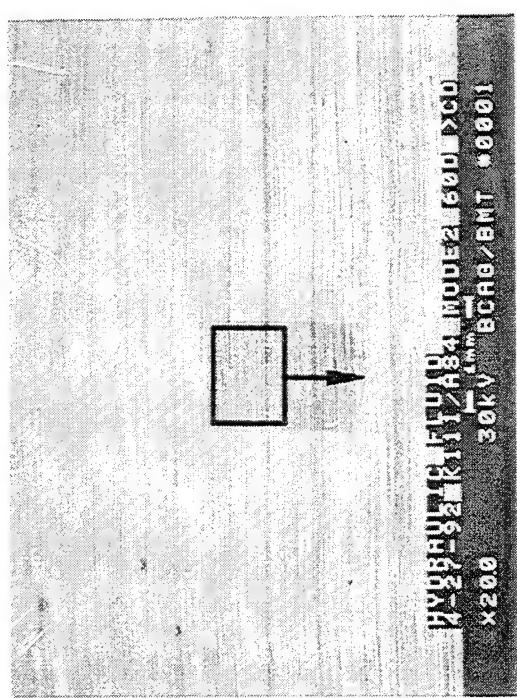
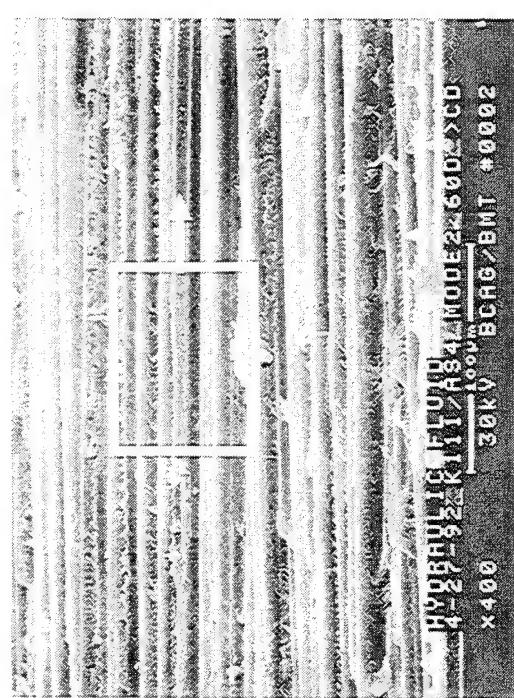
Figure 3.2-19. SEM Fractographs of a KII/AS4 interlaminar Mode II Shear Fracture Surface Exposed to Hydraulic Fluid for 7 Days

Examination of the mode II surfaces (Figure 3.2-19 through Figure 3.2-25) exposed to the various environments revealed that the hydraulic fluid (Figure 3.2-19) and JP4 jet fuel (Figure 3.2-20) slightly degraded the fracture features. The fibers appeared to be "cleaner" when compared to the control specimens. However, this did not alter the surface morphology enough to prevent identification of the mode II fracture features, such as the cusp and matrix filaments.

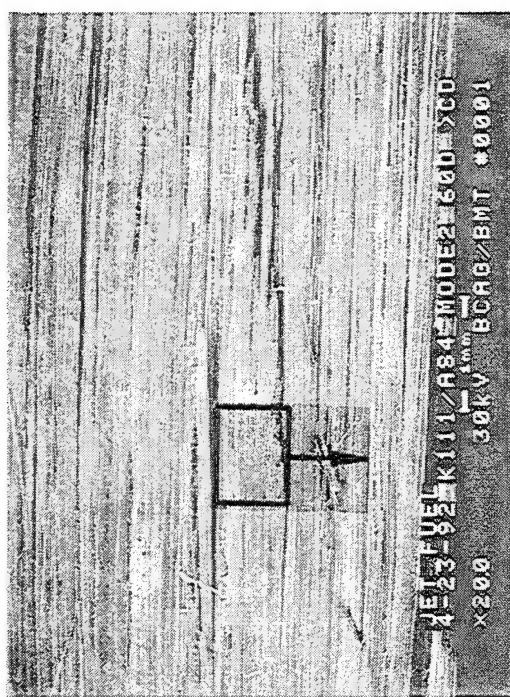
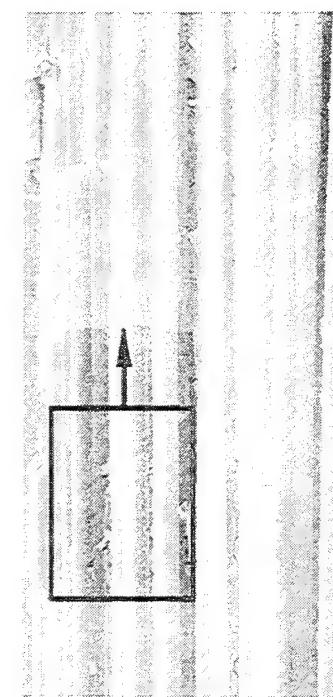
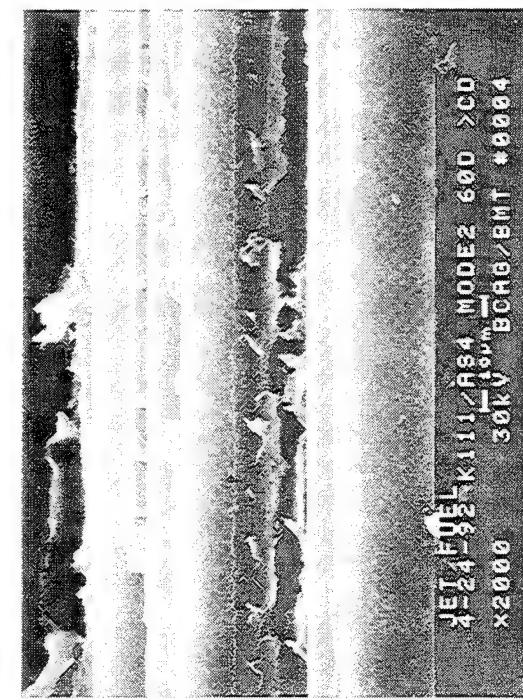
60 degree tilt (c) 2000X
Figure 3.2-20. SEM Fractographs of a K111/AS4 Interlaminar Mode II Shear Fracture Surface Exposed to JP4 Jet Fuel for 7 Days
2405.06 9-5576 D1ai

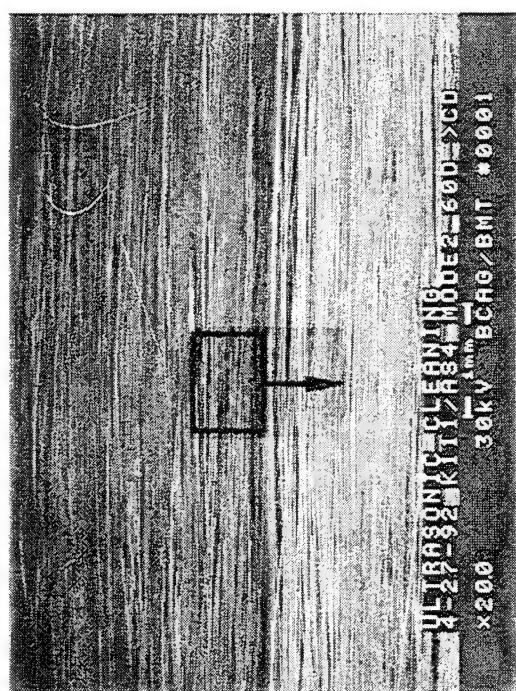
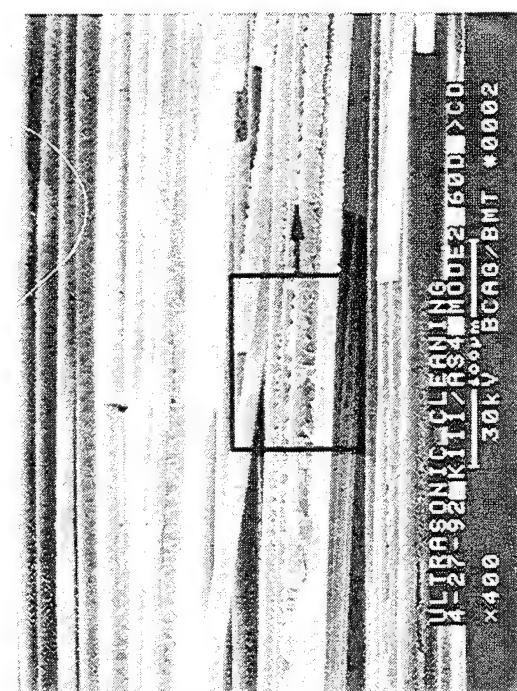
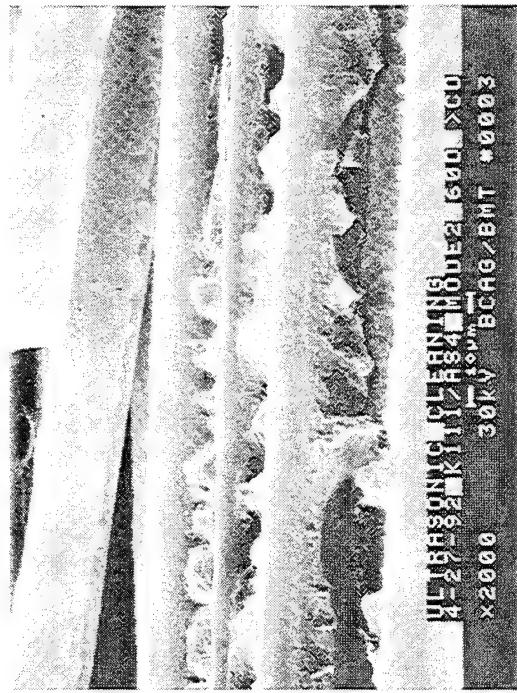
Figure 3.2-21. SEM Fractographs of a K111/ASA4 Interlaminar Mode II Shear Fracture Surface Exposed to Ultrasonic Agitation in Distilled Water for 24 hours
